INVESTIGATION REPORT OF THE FIRE AT STOUFFER'S INN OF WESTCHESTER

Harrison, New York

JAMES R. BELL

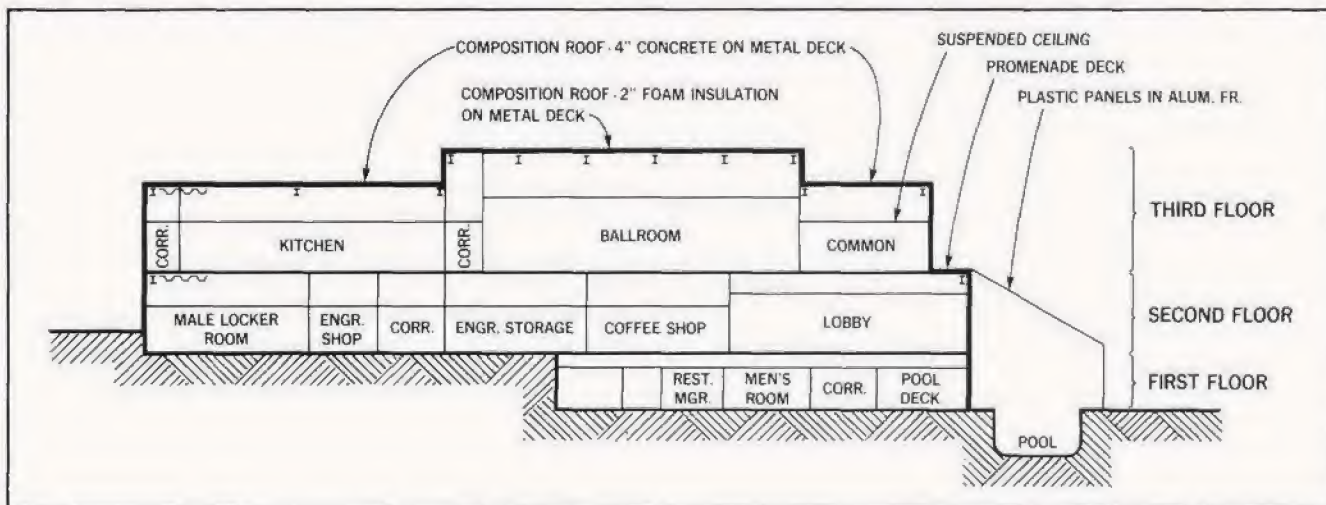
Figure 1. Section view through Ballroom. Drawing not to scale.

The three-story Main Building in which the fire occurred contained the registration desk, a restaurant, a coffee shop, lounge, pool, health club, small shops, and offices. The third floor, the floor of fire origin, contained meeting rooms, a ballroom that could be converted to additional meeting space by movable partitions, and the banquet kitchens, with ancillary service areas. The Common, a 24-foot-by-93-foot area that functioned as a lobby for the adjoining ballroom and as an accessway for other meeting areas, was located on the west side of the building. (See Figures 1 and 2 and Table 1.)

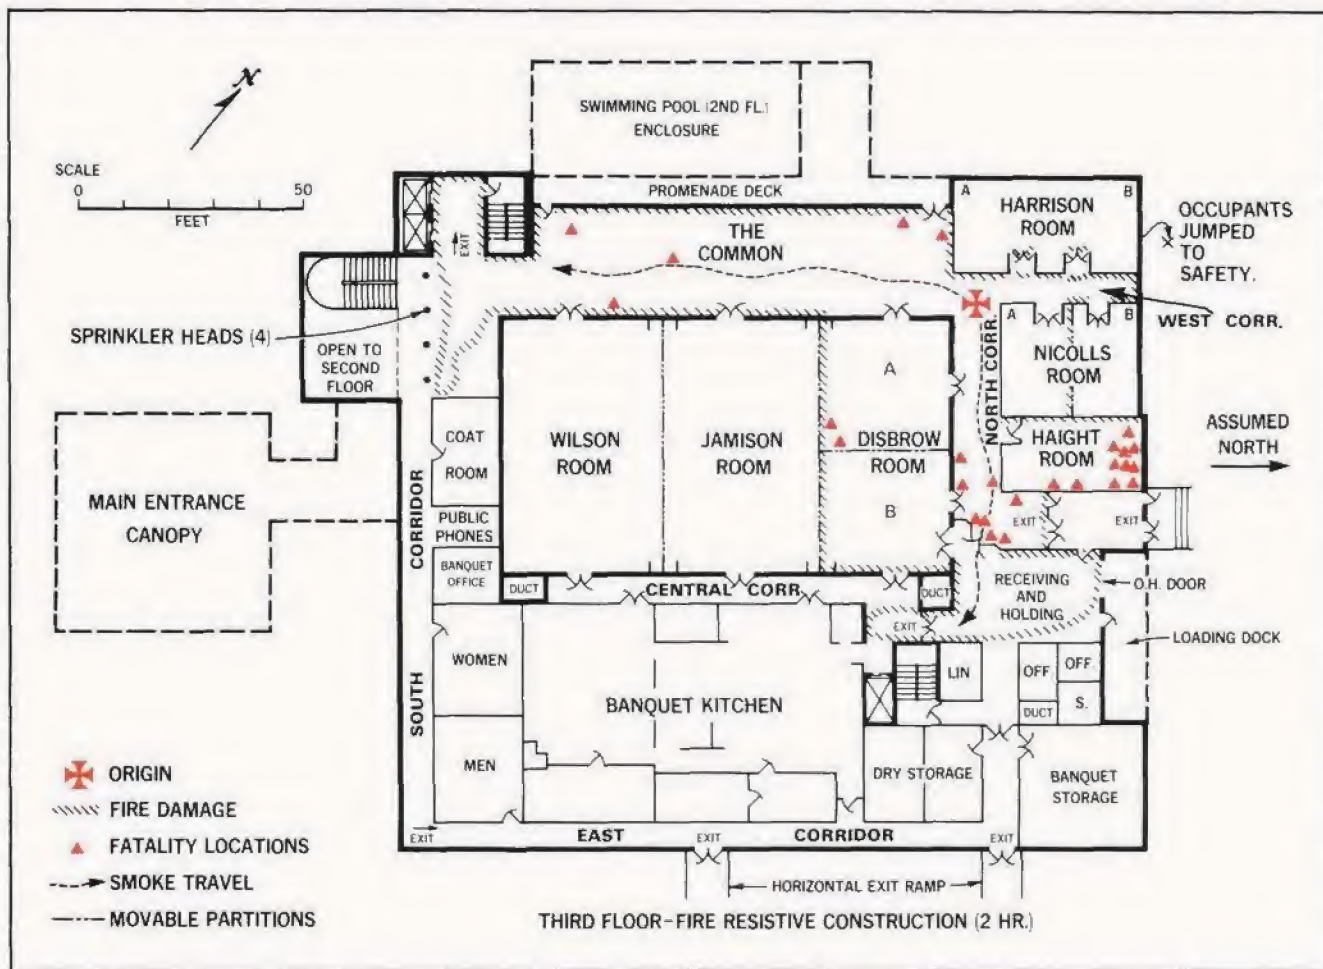
Figure 2. Layout of third floor.

The Common served as the focal point and key exit access corridor for the conference facility on the third floor and also as a lobby for the Grand Ballroom. The Common provided access to the Wilson Room, the Jamison Room, and the Disbrow Rooms, the designations for the meeting rooms that could be created within the Grand Ballroom by movable steel wall partitions. The Disbrow Room on the east end of the Ballroom could be further subdivided into two smaller meeting rooms, Disbrow Rooms A and B, by means of another movable steel wall partition. On the morning of the fire, the movable partitions had been extended to subdivide the Ballroom into four meeting areas, three of which were occupied at the time of the fire. (See Figure 2.)
